Beneath the Oil Sands: Stratigraphy and Structural Features of the Devonian of Northeast Alberta

GeoConvention 2012: Vision

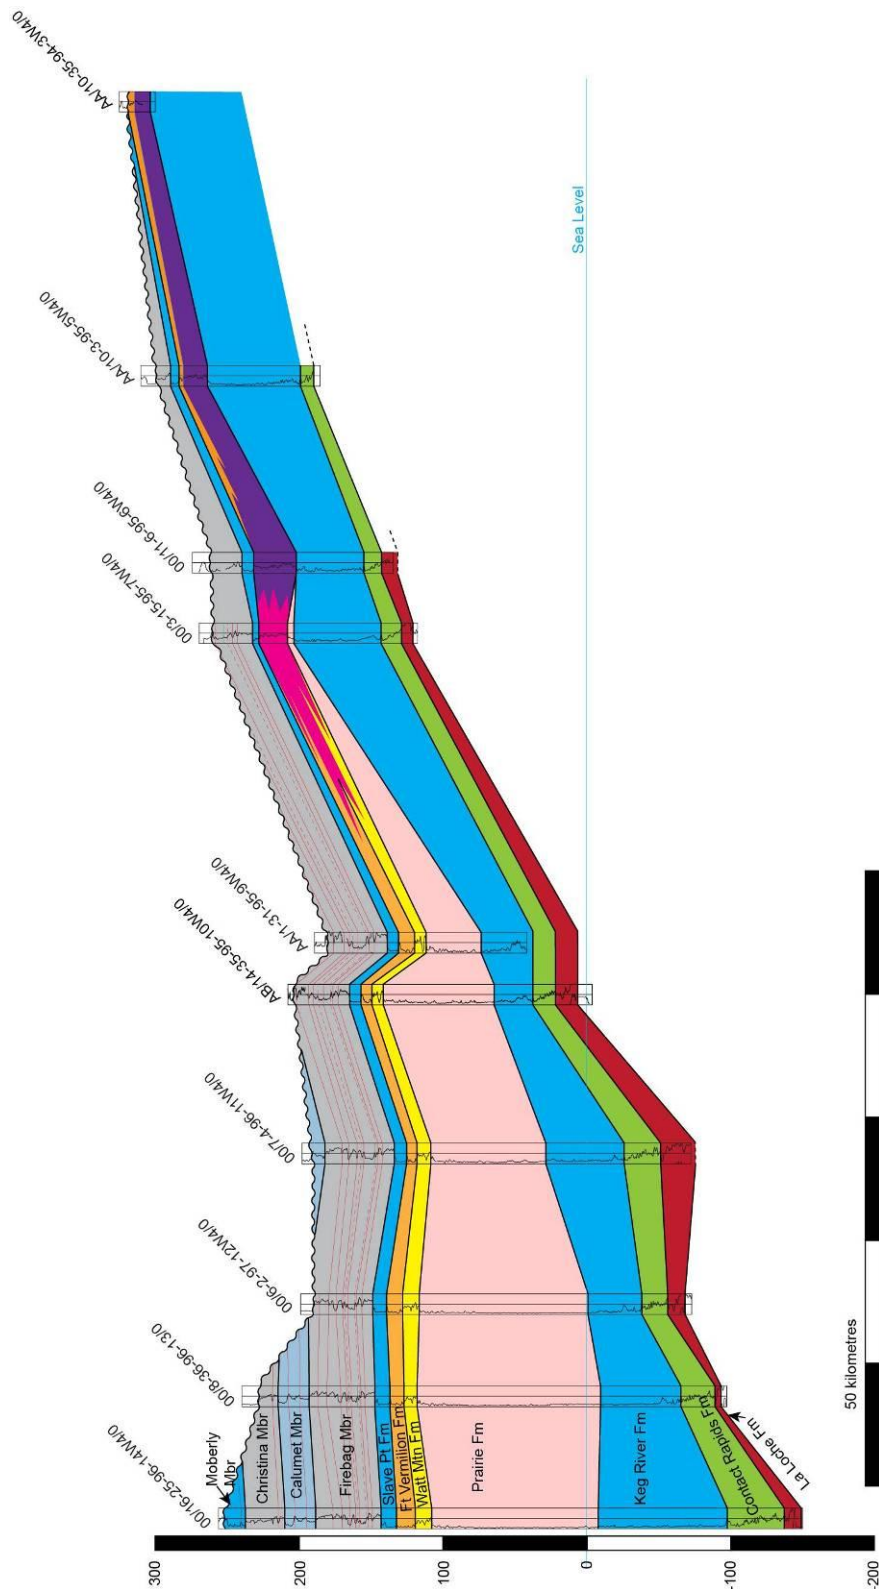
Figure 1. Cross-section of Devonian strata in deep wells through the northern portion of the study area.

Most wells penetrated Devonian strata insufficiently to recover correlative relationships deeper than the upper few metres of limestone and shale. Cross-sections reconstructed from deep wells and cores indicate (1) a complex basement surface with topographic highs and lows; (2) thinning and eventual disappearance from west to east of Prairie Formation halite, including at least one salt scarp; (3) a variably thick Keg River Formation, resulting from localized biohermal and biostromal development in the upper half of the formation; (4) thin Watt Mountain through Slave Point formations; (5) consistently thick (except where eroded) Waterways Formation members; and (6) consistent regional lithology of Devonian formations (Figure 1). Marker beds within the Waterways Formation can be traced across most of the region.

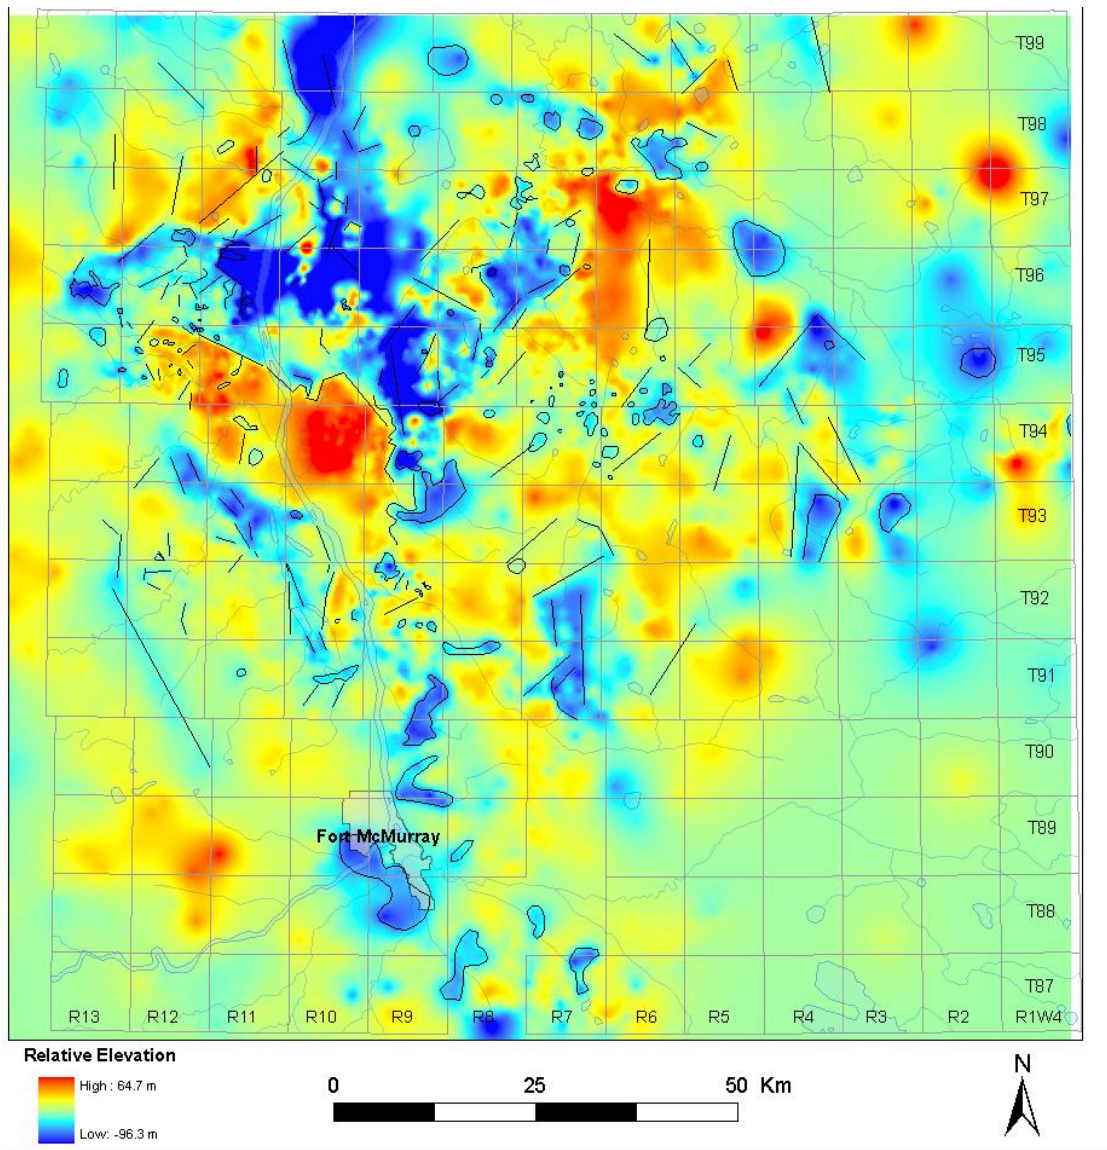
Figure 2. Residual map showing local structural features highlighted by removing the regional effect (regional dip, regional erosion and regional salt-dissolution collapsing) using the methodology described by Mei (2009a).

To reconstruct the surface of Devonian subcrop, we first used pre-Cretaceous unconformity picks to model a smooth surface to account for the basal dip trend and regional erosion effect, using the methodology described by Mei (2009a, 2009b). Then, this trend surface was removed from the data points and a residual map was created to accentuate the local structural features.

The pre-Cretaceous unconformity in the study area represents a time gap of approximately 250 Ma and a long history of erosion, non-deposition and karstification, which resulted in an ancient and mature erosional paleotopographic surface containing high reliefs and a river valley-dissected landscape (Figure 2). Linear features include escarpments, surface elevation offsets, possible faults and linear erosion of “weak” zones, such as subcropping shale. Circular features include present-day and relict sinkholes and other salt dissolution-related collapse structures.

A channel roughly parallels the present-day Athabasca River, best seen in the northern portion of the study area. A tributary channel joins the main channel north of Fort McKay.
